CPD Talywain Celta
Gladfys Gŵ, Talywain,
Gwynedd, LL54 6BY

Cynlluniau Lleoliad
Location Plans

Drawing No: OBS-2023-056 GAD01 Rev:

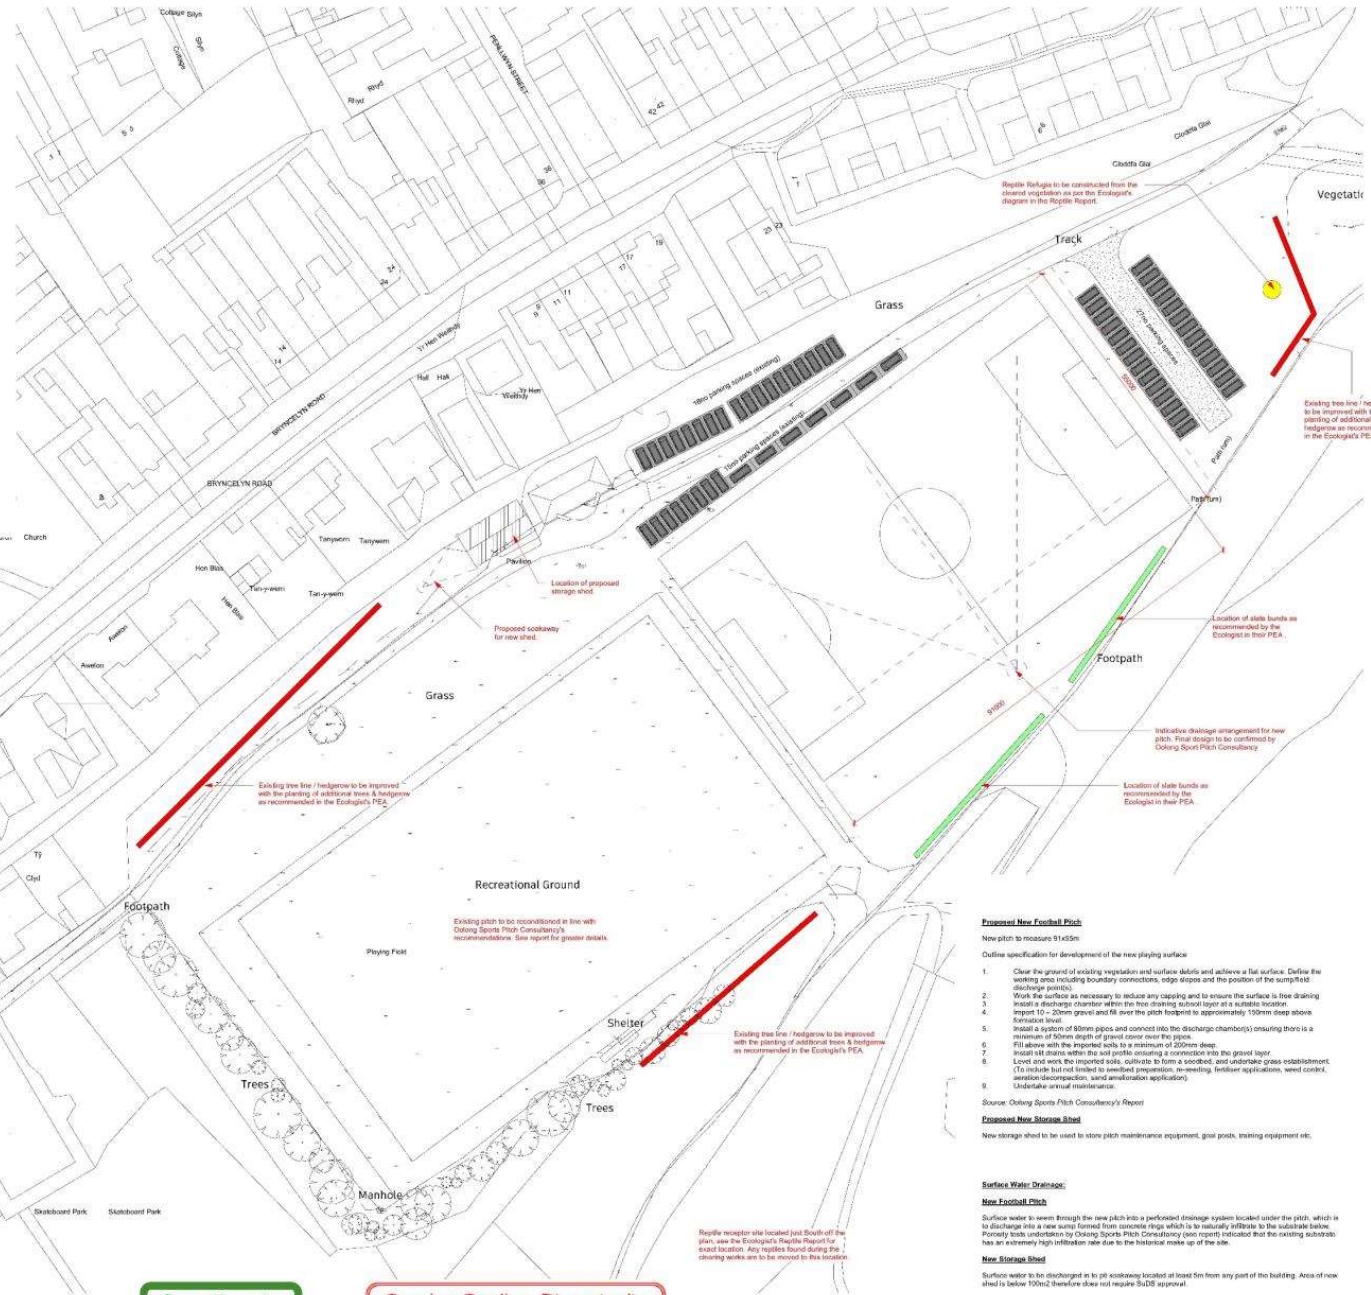
Parking

Currently the majority of the people who attend the club park in the public car park of Caerleon Talysern which is located across the road.

Those who do park on site do so in the areas highlighted opposite as existing.

The formation of a new pitch merely adds the pressure on the existing parking facilities on the location of the new pitch does not take up space used for parking. The location of the pitch is currently overgrown scrub.

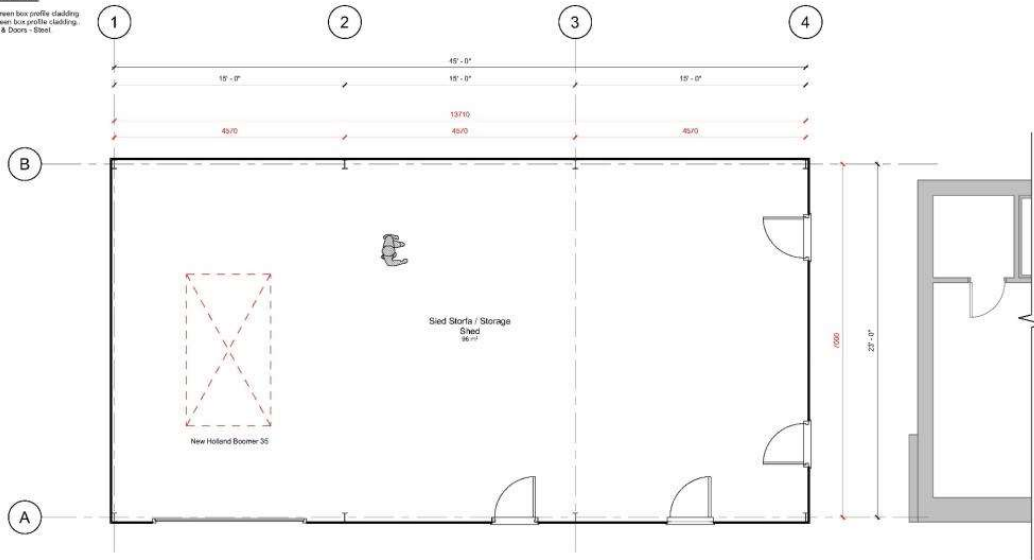
1 CYNLLUN LLAWR ARFAETHEDIG / PROPOSED FLOOR PLAN
1:50

Proposed Materials:
Walls - Green box profile cladding
Roof - Green box profile cladding
Windows & Doors - Steel
